Technological development for efficient inspection

Maintenance Engineering Division

West Nippon Expressway Company Limited.

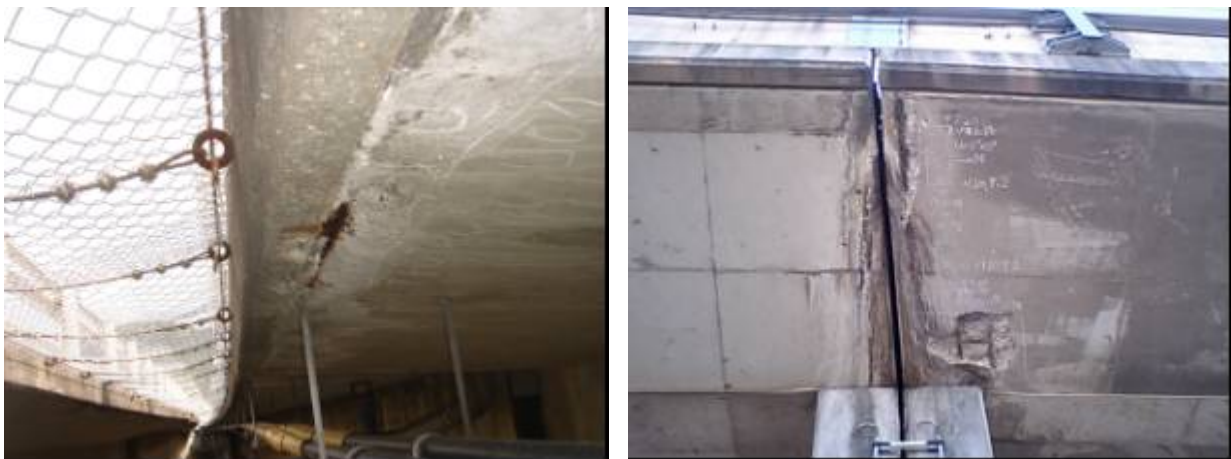
Picture-1. Concrete spalling from the edge of a slab

According to our experiences, as for bridges, concrete debris tend to spall from the edge of a slab. One of the main reasons for concrete spalling is the corrosion of rebar under the influence of water from road surface and deicing salt (see picture-1).

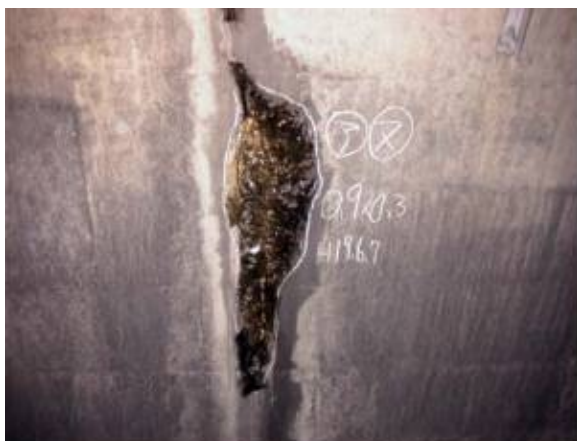
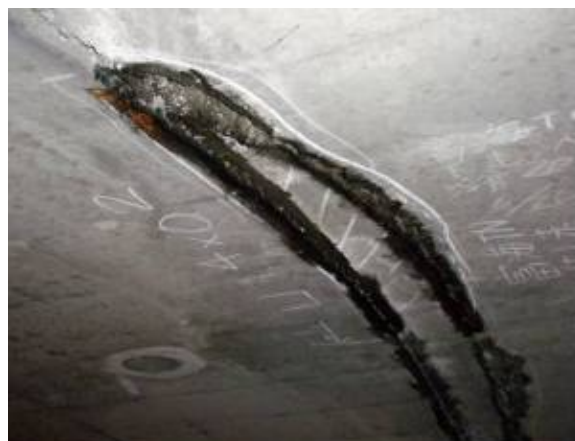
Picture-2. Concrete spalling from a joint of a concrete lining

As for tunnels, concrete debris tend to spall from a joint of a concrete lining. Mainly, initial defect during under construction work such as lack of compaction of fresh concrete and too much uplift of a centre may cause the spalling of concrete debris (see picture-2).

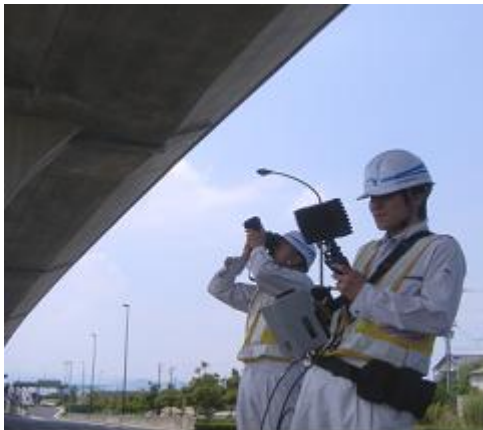
Picture-3. Inspection using infrared camera

In NEXCO-West, efficient inspection using infrared camera has been implemented for bridges that hazards to the third parties may occur by spalling of concrete debris. This inspection for whole bridge deck can contribute to screening of the area of applying sounding test, and furthermore; reduction of time and cost for inspection (see picture-3).

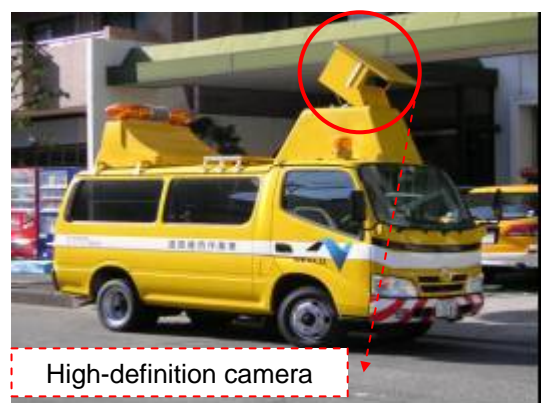
Picture-6. Inspection vehicle

The system detecting cracks of pavement is composed of the GPS navigation system, high-definition camera, and laptop computer, and those are included inside the inspection vehicle as shown in picture-6. Vehicle location

data is obtained from GPS. The high-definition video camera is attached on top of the inspection vehicle to record the surface condition.

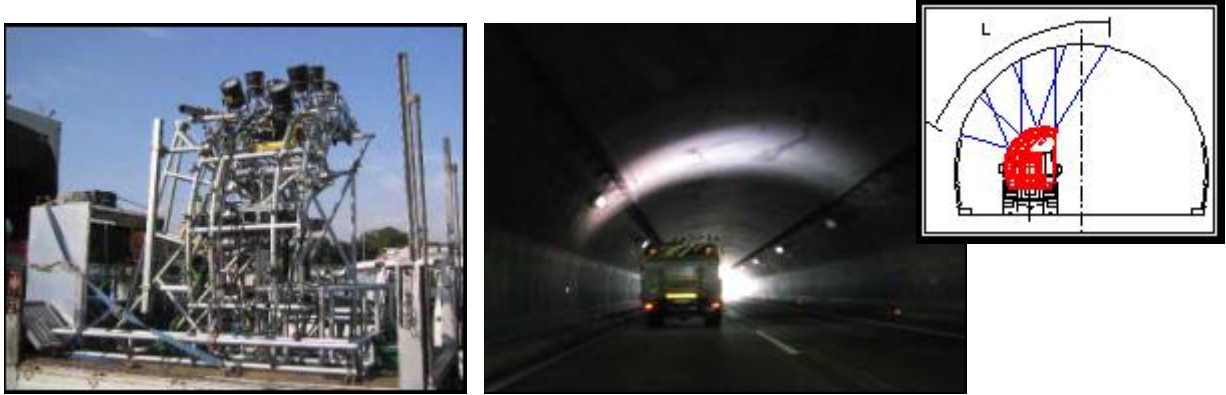
Picture-9. Truck equipped with devices taking pictures

Pictures of concrete linings are taken by the truck equipped with four high-definition cameras, metal

halide lamp for lighting and recording devices as shown in picture-9. Running on a nearside and a passing lane enables to take pictures covering an upper-half lining. This crack detection system can detect cracks with about 0.2mm width at 80km/h.
